CASE REPORT

Root perforation associated with the use of a miniscrew implant used for orthodontic anchorage: a case report

McCabe P, Kavanagh C. Root perforation associated with the use of a miniscrew implant used for orthodontic anchorage: a case report. *International Endodontic Journal*, **45**, 678–688, 2012.

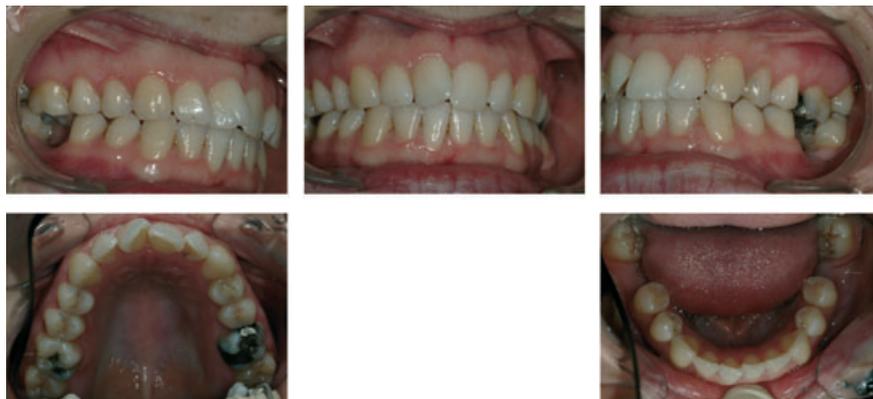
Figure 1 Pre-treatment orthodontic records.

A 25-year-old female caucasian attended for orthodontic treatment, unhappy with the crowded and rotated appearance of her maxillary anterior teeth (Fig. 1.).

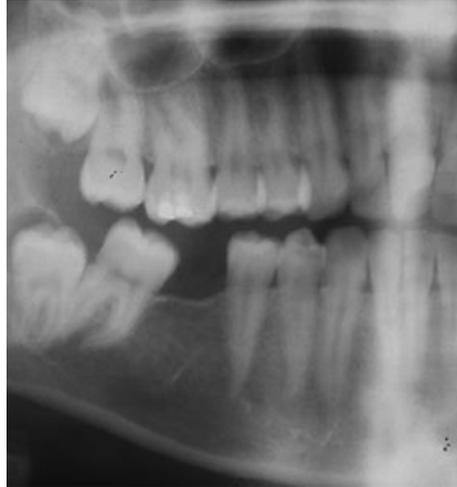
Figure 2 Cropped OPT showing right side.

The pre-treatment OPG radiograph was used to assess possible sites for miniscrew placement (Fig. 2). A site between the maxillary second pre-molar and first molar tooth was identified as being the most suitable. Local anaesthetic (Lignospan Special; Septodont, Paris, France) was given, and a round bur was used to mark the attached buccal mucosa and cortical bone. Two self-screwing 8-mm long 1.3–1.2 mm tapered miniscrews were used. On placement of the miniscrew in the maxillary right buccal quadrant, it was noted that the miniscrew 'kept turning' but was not engaging the buccal bone. On further examination, the miniscrew tip was missing. A periapical radiograph revealed the retained miniscrew tip was in close proximity/overlying to the mesio buccal root of the maxillary first molar (Fig. 3). The patient was advised about this complication and an agreement reached to monitor the situation.

In this case, a miniscrew site assessment was made on an OPG (Fig. 2). The so-called 'safe zone' in the maxilla was the preferred site. The only issue to consider was the distance above the alveolar crest to place the miniscrew. It was decided to place it as high up as possible but to keep the miniscrew in the attached gingiva, to increase its potential for survival (Viwattanatipa *et al.* 2009). Figure 4 shows the ensuing fistula from the actual position of the miniscrew after the tip had separated. It is apically positioned almost at the junction of the free and attached gingiva. However, when this is compared to the periapical radiograph taken immediately after the tip fractured (Fig. 3), the radiographic image suggests that the site chosen was much closer to the alveolar crest. This is the difficulty associated with miniscrew placement. It is impossible to predict accurately using a two-dimensional image where the roots are located. This is further compounded by the fact that these miniscrews perform better when they are placed in the attached gingiva.

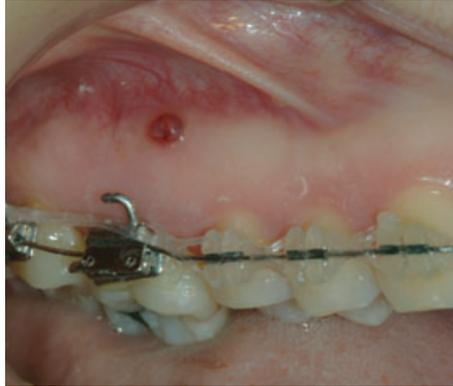
Figure 4 Sinus tract over 16 following miniscrew fracture.

Ten days later, a buccal sinus tract appeared from the root region associated with tooth 16 (Fig. 4). Sensibility tests elicited a positive response from the tooth.

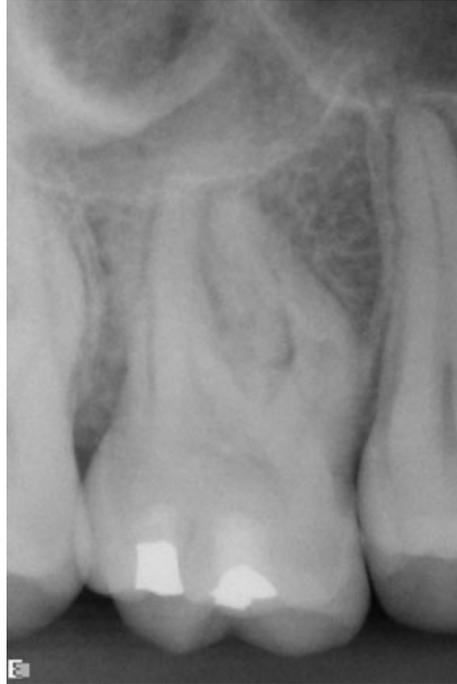
Figure 6 Periapical view of tooth 16 following miniscrew removal.

obstruction (Fig. 7), and the perforation had occurred in an area where there was abrupt curvature (Figs 3 and 6). It was therefore decided to complete the root filling to the level of the perforation with a view to carrying out apical surgery to remove the root apex below the perforation. Treatment was completed over two visits. An interim dressing of calcium hydroxide (Ultracal XS; Ultradent Products Inc., South Jordan, UT, USA) was placed. A post-treatment radiograph was taken (Fig. 8) to assess the quality of the root filling in the DB and P canals.

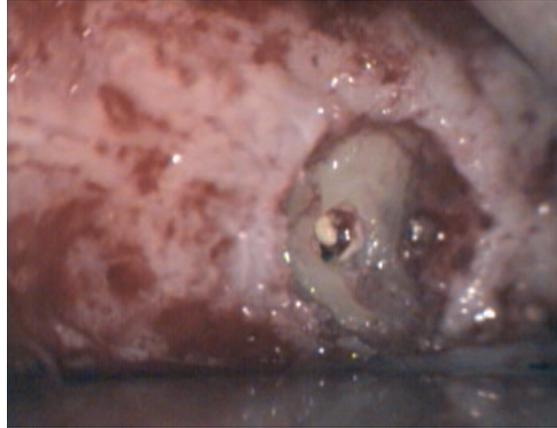
Figure 7 View of surgical field following flap reflection and granulation tissue removal.

MO, USA). The canals were explored with hand K-files. The disto-buccal and palatal canals were patent. Both the MB and MB2 canals were obstructed. It was not possible to bypass the obstruction. Root canal treatment was completed using a 5% solution of sodium hypochlorite as the primary irrigant and 17% EDTA used to remove the smear layer. The canals were shaped using a combination ProTaper and .06 Profiles (Densply Maillefer, Ballaigues, Switzerland). The canals were filled with gutta-percha (Autofit; Sybron Endo, Orange, CA, USA) and root canal sealer (Roth Root Canal Cement; Roth International Ltd., Chicago, IL, USA) using a vertical compaction technique. Treatment of both the distobuccal and palatal roots was uncomplicated. However, treatment of the mesial root was challenging. There were three factors that prevented the placement of a technically satisfactory root filling in this root: the perforation was large and located on the buccal aspect of the root (Fig. 7), debris had been intruded into the perforation site creating an

Under local anaesthetic, a full periosteal flap with two vertical releasing incisions was raised. There was an obvious bony fenestration at the site of the perforation. On curetting the granulation tissue in this fenestration, the perforated root was uncovered (Fig. 7).

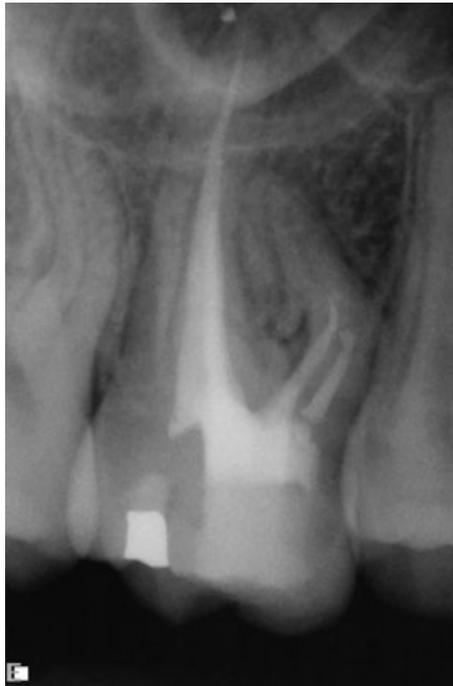
Figure 8 Periapical view of tooth 16 following root canal treatment, October 2005.

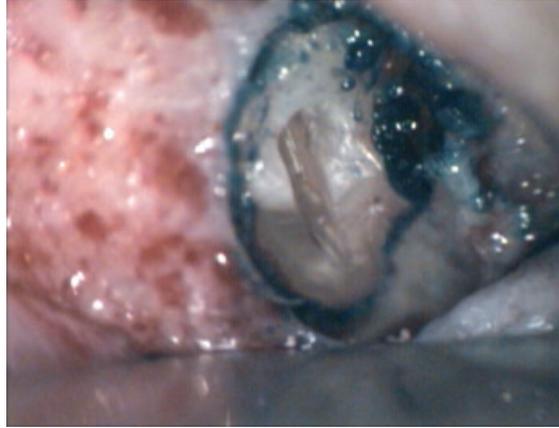
Figure 9 Resected root face showing root preparation stained with methylene blue.

The bone apical to the perforation was removed, and the MB root was resected to include the perforation. The resected root-end was prepared using an ultrasonic tip (KiS Microsurgical Ultrasonic Instruments, Obtura Spartan, CA, USA) (Fig. 9) and the root-end cavity dried using a Stropko irrigator (Sybron Endo, CA, USA) and filled with MTA (MTA-Angelus, Londrina, PR, Brasil). The flap was sutured using 06 monofilament sutures (Prolene; Ethicon Inc, Somerville, NJ, USA). A post-treatment radiograph was taken (Fig. 10) to assess the quality of the filling.

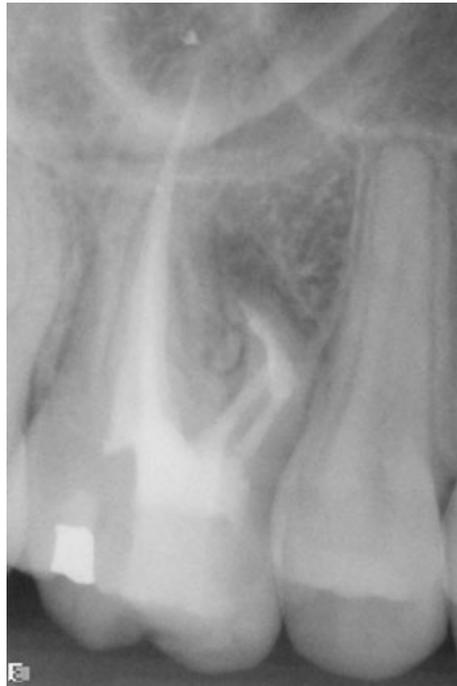
Figure 10 Periapical view of tooth 16 following completion of surgical treatment, November 2005.

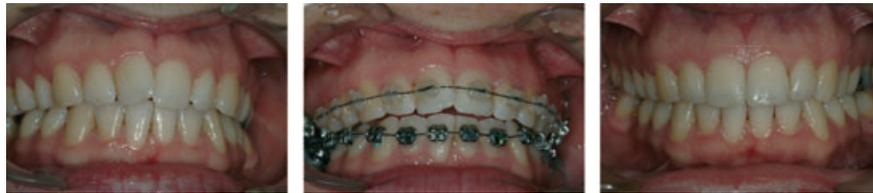
Figure 12 Post-treatment orthodontic records.

Continued follow-up over 5 years has shown a successful outcome from both an orthodontic and an endodontic perspective (Figs 11 and 12). Clinically the tooth has remained symptom-free. At the last recall visit, there was no tenderness to buccal palpation and no tenderness to percussion. There has been no periodontal attachment loss and no pocketing. Radiographically, there are no signs of periapical disease.
