Avoiding perforations in endodontics

Journal of the Irish Dental Association Volume 52: 139 - 148, 2006

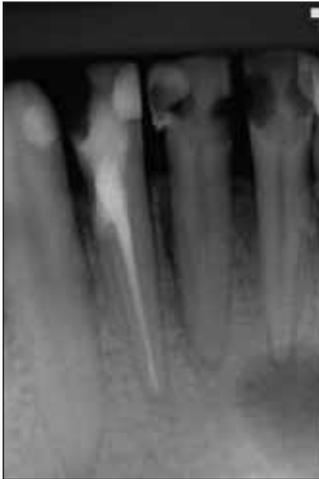
FIGURE 6: Mandibular lateral incisor which has a lateral root perforation following disorientation during access preparation. The mandibular incisors pose real problems because of their size.

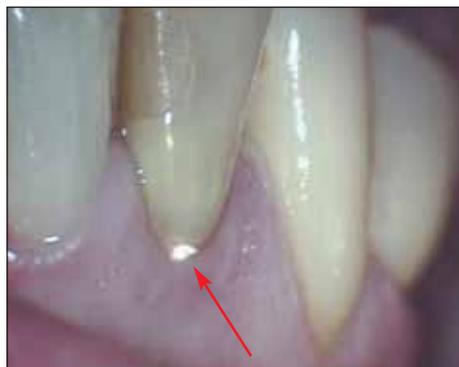
FIGURE 9: Shows the labial view of the same tooth at presentation with the temporary perforation repair just visible at the free gingival margin.

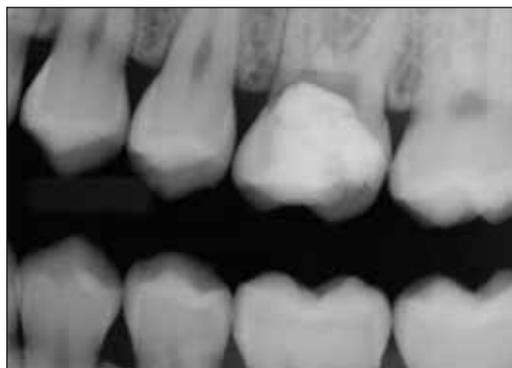
FIGURE 14: Shows the bitewing view of a maxillary first molar with a mesial perforation following the excessive removal of tooth structure as a result of disorientation and failure to keep to a definite access outline.

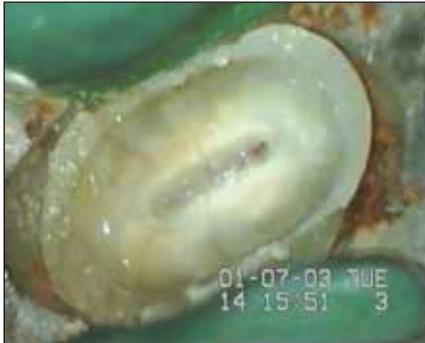
FIGURE 15: Maxillary second premolar following decay removal showing the white axial walls and the greyish calcified pulp chamber which is darker in colour and located centrally. The pulp chamber follows the outline of the root at the cemento-enamel junction level.

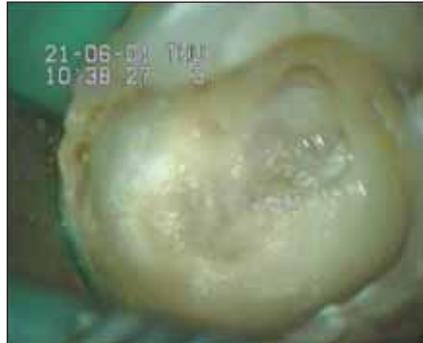
FIGURE 16: Maxillary right first molar showing calcification of the pulp chamber. However the outline of the chamber is still visible.

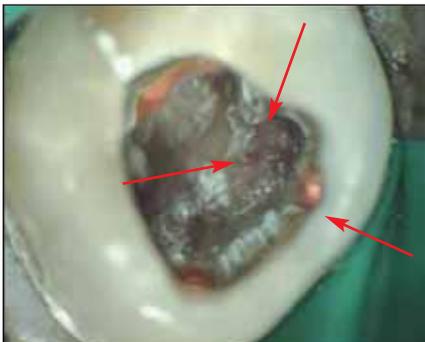
FIGURE 18: Shows the floor of the pulp chamber of a mandibular left second molar. The area highlighted by arrows is 'blushing' indicating that this is, in all probability, a micro-perforation of the chamber floor. This was subsequently repaired by lining the pulp floor with MTA after completion of the required root canal treatment.

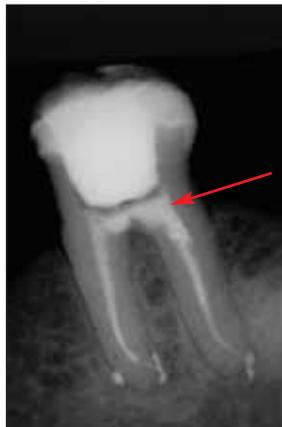
FIGURE 19: Shows the radiographic view of the completed root filling on the mandibular left second molar seen in Figure 18. A layer of MTA has been placed across the floor of the pulp chamber and into the canal orifices illustrated by the arrow.

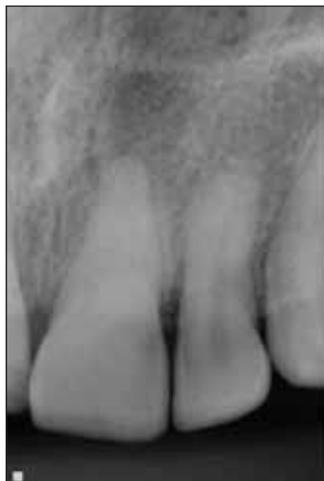
FIGURE 20: Periapical radiographic view of a maxillary left central incisor with a large periapical radiolucency and showed very obvious pulp obliteration. Clinically this tooth was symptomatic

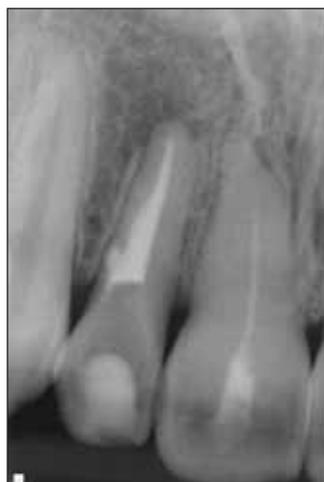
FIGURE 24: Shows the perforation repair of the tooth shown in Figure 23.

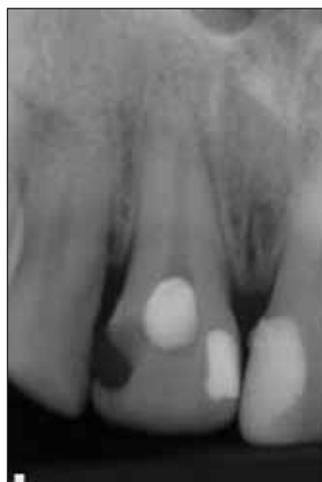
FIGURE 25: Shows an upper right maxillary central incisor which has been perforated as a result of over vigorous use of a rotary instrument - probably a Gates Glidden drill - in an attempt to get to working length quickly. Note the pronounced canal straightening and again the positioning of the access cavity which is directing the instrument into the labial wall of the root.

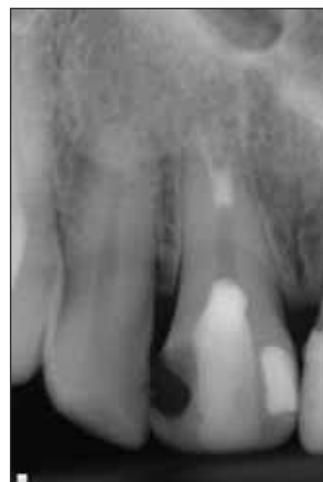
FIGURE 26: Shows the recaptured canal in Figure 25 and the repair which was obturated with MTA.

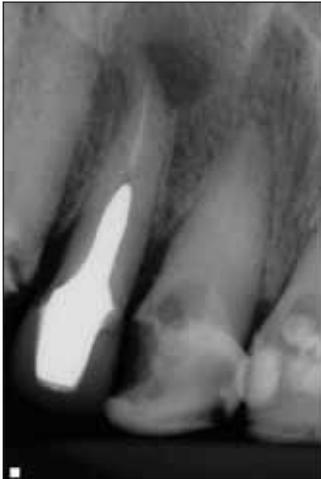
FIGURE 27: The radiographic view of a maxillary right lateral incisor with a root filling which is short of the radiographic apex. There is pronounced straightening of the canal system which fails to negotiate the significant apical curvature. There is a lesion centred at the termination point for this root filling. This is suggestive of a perforation created by taking excessively stiff instruments deep into the root canal system.

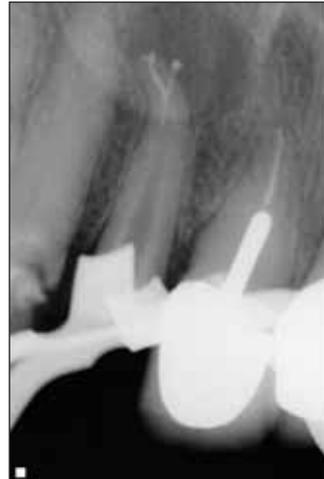
FIGURE 28: Shows the disassembled maxillary right lateral incisor seen in Figure 27. The original canal system has been recaptured, prepared and obturated using a warm vertical compaction technique. The repair of the perforation was carried out with sealer and gutta percha in an attempt to avoid surgical repair.

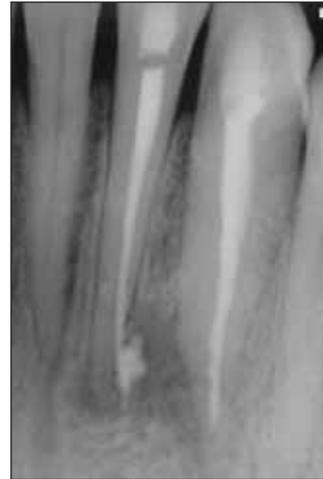
FIGURE 29: A periapical radiographic view of a mandibular left lateral incisor with a perforation in the apical third of the root denoted by the excess root filling material on the lateral aspect of the root. There is an associated periapical lesion. It is probable that this perforation resulted from the mis-use of a rotary instrument. It is necessary to prepare the canal system using a handfile up to an ISO #15 before introducing the rotary instrument to create what is known as the 'guide path'.

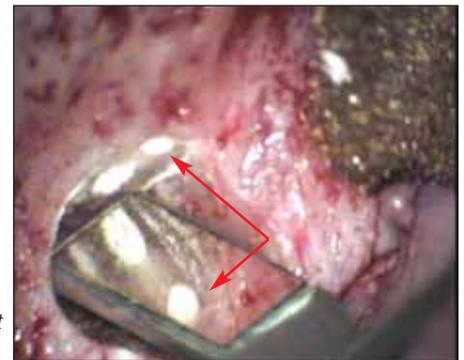
FIGURE 30: Shows the actual surgical field during the repair of the same mandibular left lateral incisor as seen in Figure 29. The root apex has been resected above the level of the perforation. Both the anatomical and the created canal have been ultrasonically prepared and filled with MTA. The arrow indicates the created canal which is perfectly rounded.

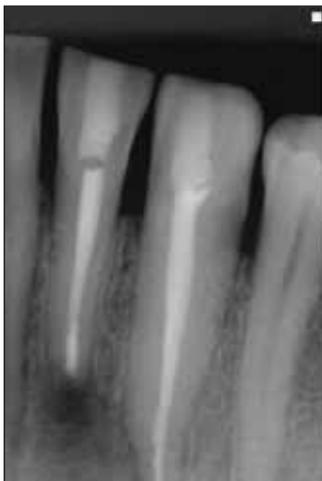
FIGURE 31: Shows the radiographic appearance of the surgically corrected mandibular left lateral incisor as seen in Figures 29 and 30. The limitations of the surgical approach are clear to see. While the perforation has been removed and the root repaired, a large portion of the anatomical canal system remains un-obtured.

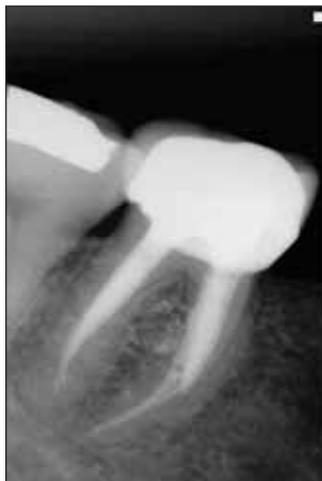
FIGURE 32: Shows a radiographic view of a mandibular first molar. Excessive root preparation has occurred in the mesial root on the furcation side, resulting in a near perforation or microperforation. This could have been avoided by using smaller instruments less aggressively in the first place, and directing them away from the furcation side of the root.

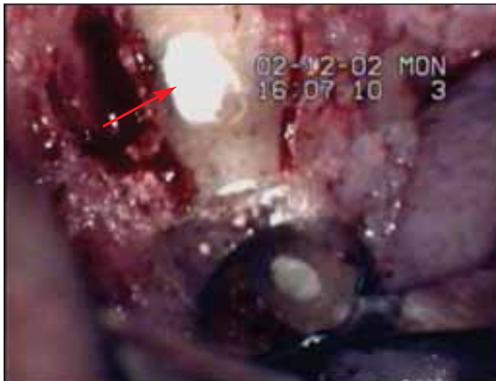
FIGURE 35: Shows the actual surgical correction of the tooth seen in Figure 34. It would appear that during post space preparation the rotary drill was advanced into the apical third of the root causing the perforation. The root tapers very quickly in this area. The root has been resected and prepared ultrasonically before being repaired with MTA. The arrow denotes the perforation repair.

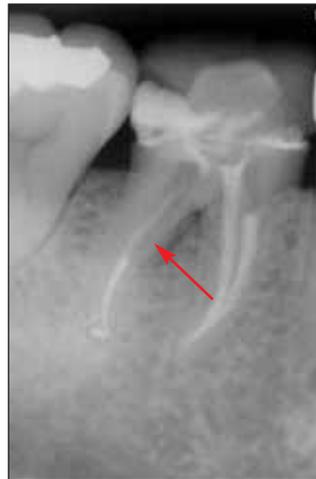
FIGURE 36: Radiographic view of a lower first molar with a perforation in the distal canal on the furcation side following post space preparation. The arrow indicates the actual perforation.

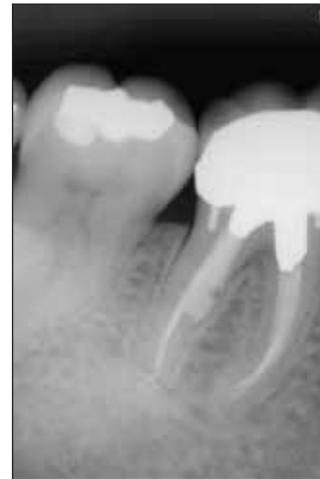
FIGURE 37: Shows the radiographic view of the tooth in Figure 36 following the perforation repair with MTA and the placement of the definitive cast restoration. It is worth noting that an amalgam core supplemented with pin placement was sufficient to retain the crown. This suggests that the need to place the post in the first place was questionable putting the tooth at great risk.
